3 Watershed Resource Inventory & Characterization

3.1 Watershed Boundaries

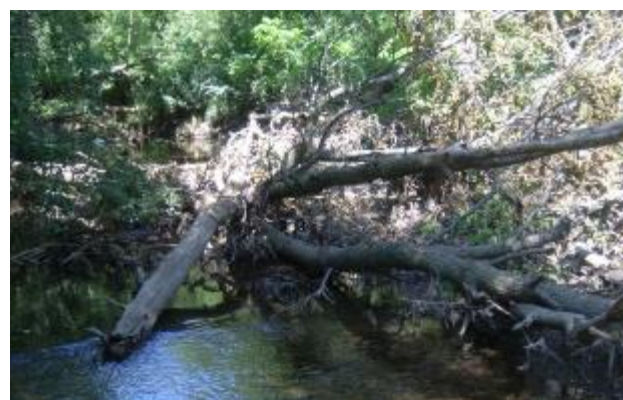
Photo of a stream reach that fails the debris load test in the Buffalo Creek Watershed, courtesy of SMC.

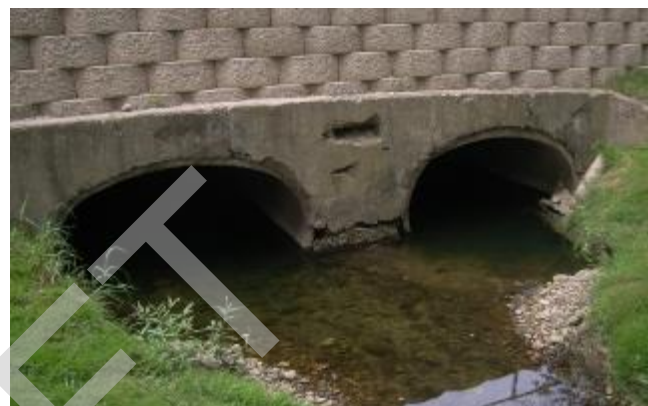
Photo of culverts in the Buffalo Creek Watershed, courtesy of SMC.

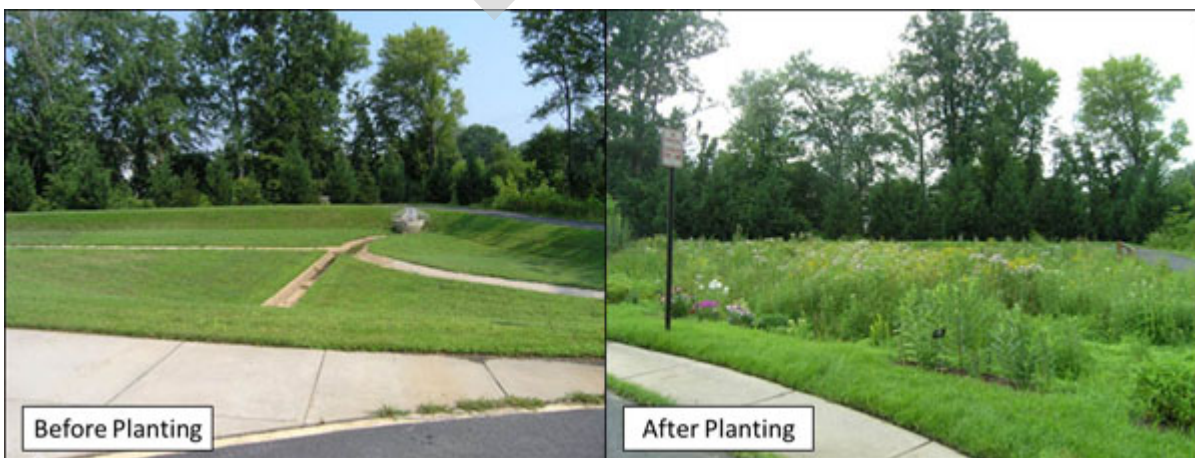
Example of a detention basin retrofit. Source: Fairfax County Soil & Water Conservation District.
